Home Inspections

Property Report

Property Address: 402 South Sunny Court, Goodtown OH 44355

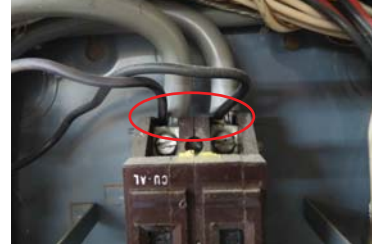
^ THE DUEL MINI BREAKERS # 6,8 AND 10 IN THE MAIN PANEL ARE DOUBLE TAPPED.

***THE MAIN BREAKER LUGS ARE DOUBLE TAPPED TO FEED THE SUB-PANEL (SAFETY HAZARD, 100 AMPS ON A 40 AMP WIRE, CANNOT SHUT OFF POWER TO THE SUB-PANEL WITHOUT REMOVING THE ELECTRIC METER).*

Have Service and Panel Boxes Reviewed for Repairs / Replacement by Competent Licensed Electrician.

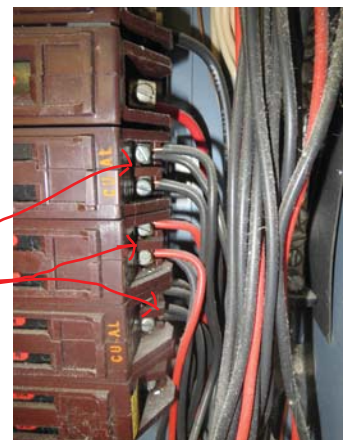
6 DOUBLE TAPPS ON MAIN PANEL
